MEMORANDUM

SUBJECT: Potlatch Free Product Recovery System

Avery Landing Site, Avery, Idaho

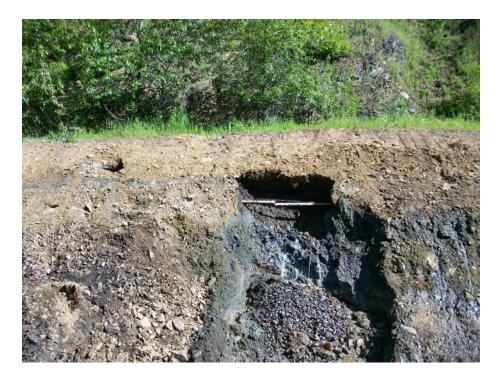
1. Excavation of the FPRS infiltration trench (note the presence of the two PVC pipes – one solid [carrier] pipe and one perforated pipe – in the infiltration trench)

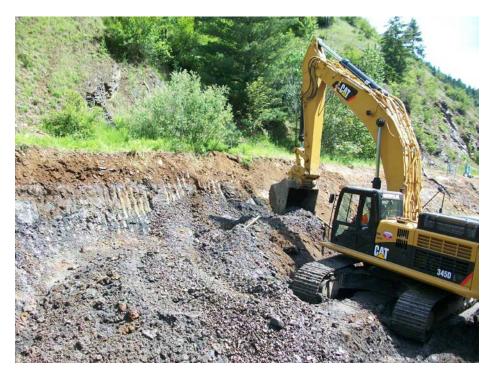
2. Excavation of the FPRS infiltration trench (note the outline of the infiltration trench and the presence of the PVC pipe, crushed rock, and petroleum-stained soil)

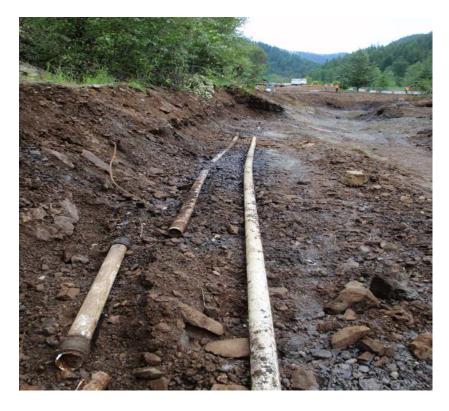
3. Excavation of the FPRS infiltration trench; 3-inch PVC carrier and infiltration pipes (facing east)

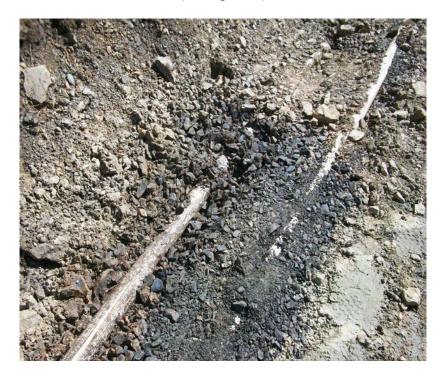
4. 3-inch PVC carrier and infiltration pipes surrounded by crushed rock and embedded in infiltration trench

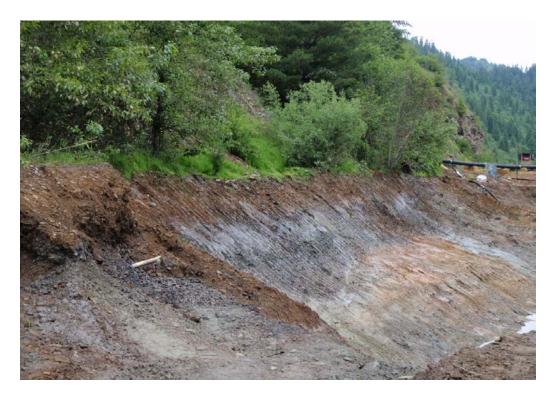
Petroleum was visibly observed in the subsurface soil throughout the entire length and width of the infiltration trench, and a strong petroleum odor was also noted along the full length of the trench. Petroleum was also observed in soil north and south of the constructed dimensions of the infiltration trench, and petroleum-stained soil was visible 6 to 8 feet below the bottom of the crushed rock-filled infiltration trench (see Photographs 5, 6, and 7).

5. Excavation of the FPRS infiltration trench (facing east) (note the outline of the infiltration trench and the presence of petroleum-stained soil)

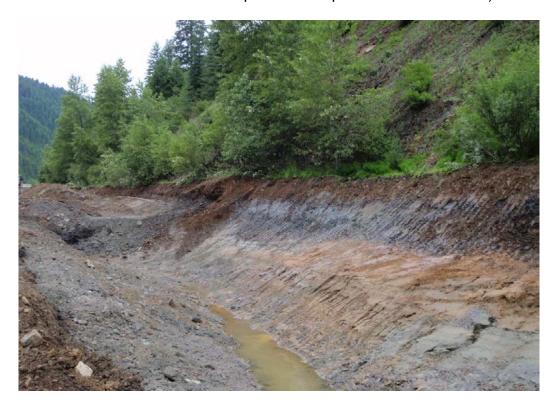
6. Excavation of the FPRS infiltration trench (facing west) (note the outline of the infiltration trench and the presence of petroleum stained soil)

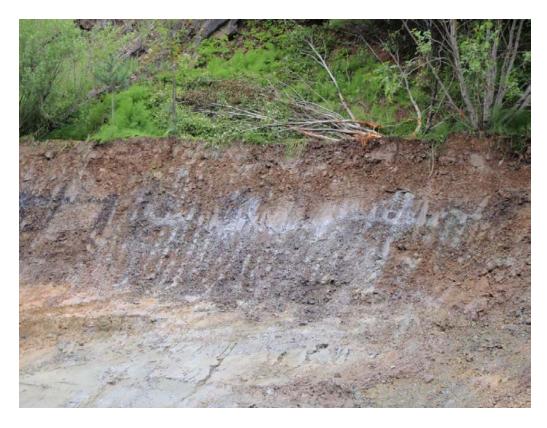
7. Excavation of the FPRS infiltration trench (note the outline of the infiltration trench and the presence of petroleum-stained soil)
